The story
of the
Berkeley Fire

The Story of the
BERKELEY FIRE
Of September 17, 1923

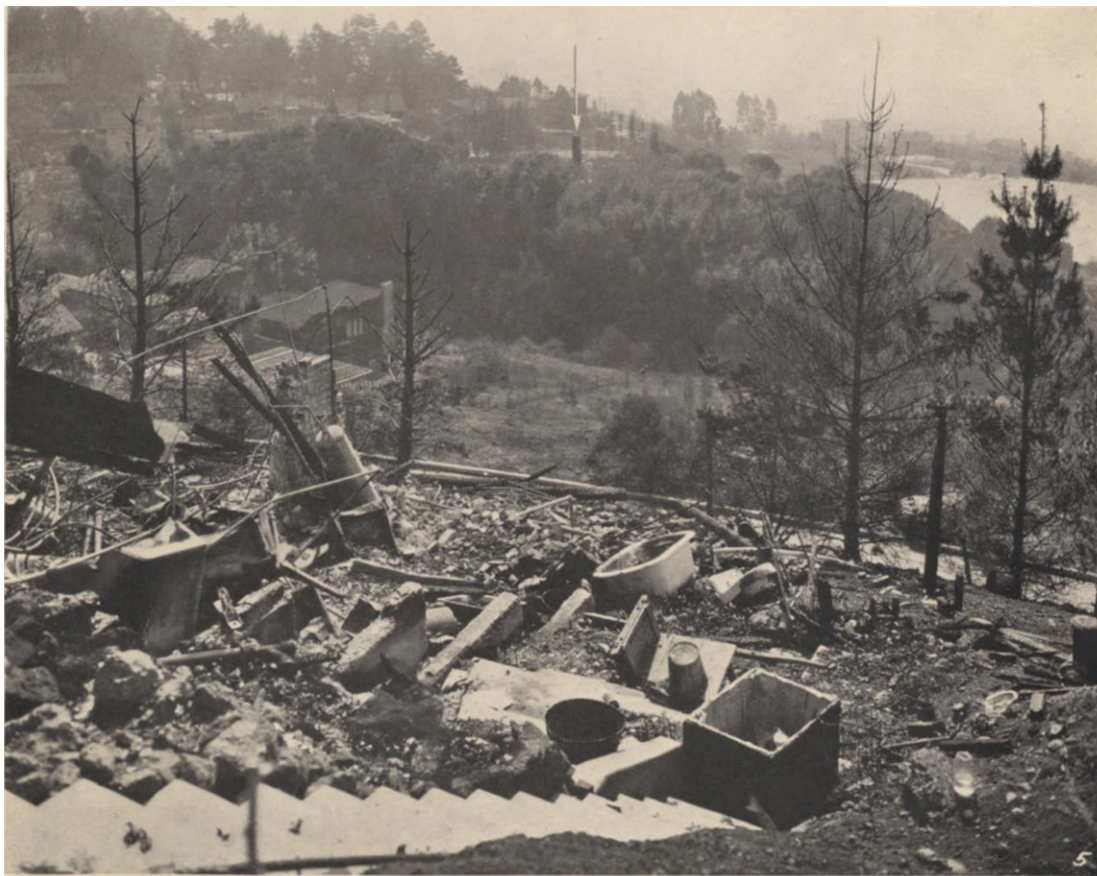
**Site of home of Professor
Arthur G. Brodeur,**
125 Shasta Road.

Arthur G. Brodeur, being duly sworn, deposes and says that his home at 125 Shasta Road, Berkeley, was the first house to be destroyed in the Berkeley conflagration of September 17, 1923; and that his home caught on side walls from burning grass and adjacent pine trees, and that the shingled roof caught from the side-walls and was last to burn.

That her house at 1350 Tamalpais Road, Berkeley, was the second house to be destroyed in the Berkeley conflagration of September 17, 1923; and that her house caught on the side walls from burning grass and adjacent brush and that the shingle roof caught from the side walls and was last to burn.

Arrow at top center, home
of Mrs. Ethel M. Underhill,
1350 Tamalpais Road.

Looking Southwest—First (“Key”) house to catch fire—an all-shingle home. Owner absent. Side walls caught from burning pine trees around house. (See affidavit.) Second house to catch fire can be seen in center across draw. Owner states that fire (fanned by 40-mile gale) roared up through brush and set fire to side walls (see affidavit)—that house did not catch from roof nor from burning shingles from first home, as claimed. If shingles blew from “Key” house, why did all shingle roofs in draw escape undamaged? They were directly in path of flames, but clearing saved them from brush fire.

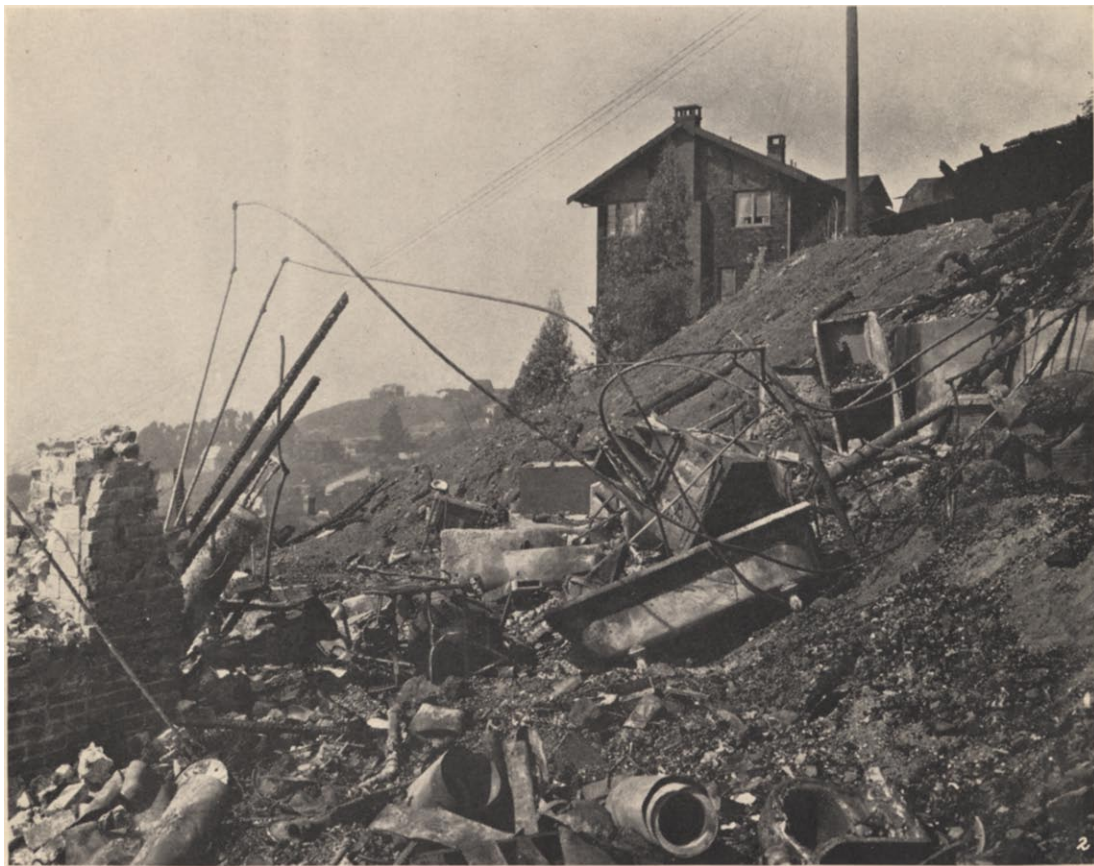
Home of Professor Tolson,
University of California,
on Shasta Road (at top right).

Looking Northeast—An all-shingle home directly in the path of the strong wind and adjoining first house to catch fire. This house was not surrounded by trees and suffered no damage to the roof. The side wall was partially scorched, as indicated by small amount of repair shown.

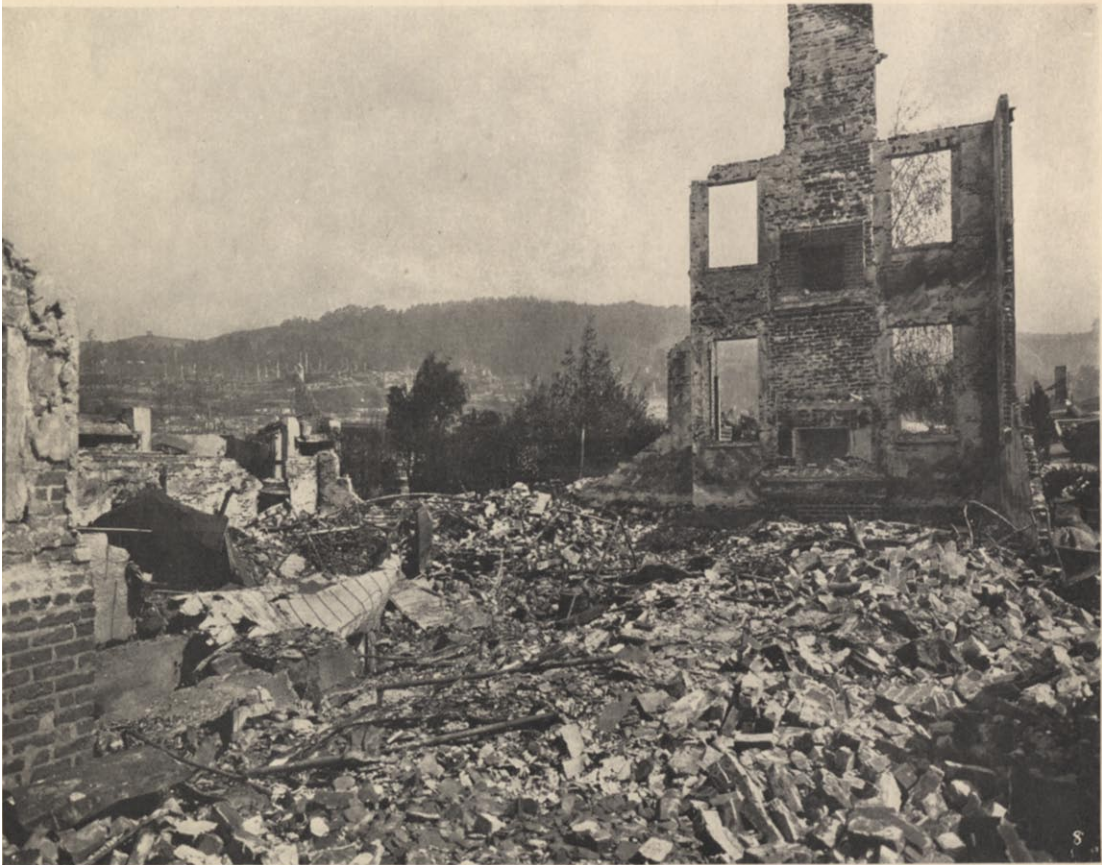
Ruins of home of Mr. Ralph Merritt,
Comptroller, University of California.

This picture tells a graphic story of what happens to a brick house, with a slate roof, in the path of a conflagration like the Berkeley fire. It is a significant fact that of all the houses saved in this memorable fire many had shingle roofs and not a few were all-shingle houses.

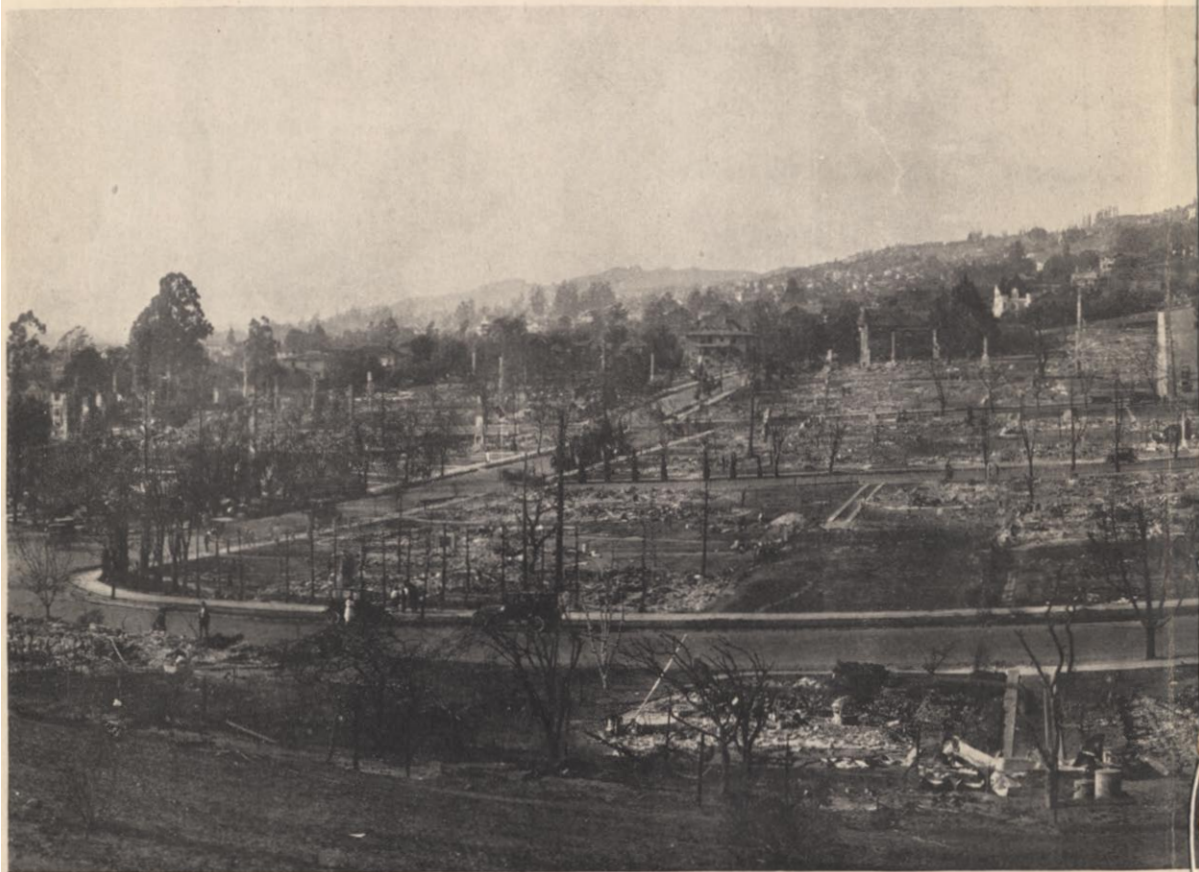
Brush and grass fires swept over hill in background. The arrow at the center, near top, points to location of first house to catch fire. (See illustration and affidavit.)

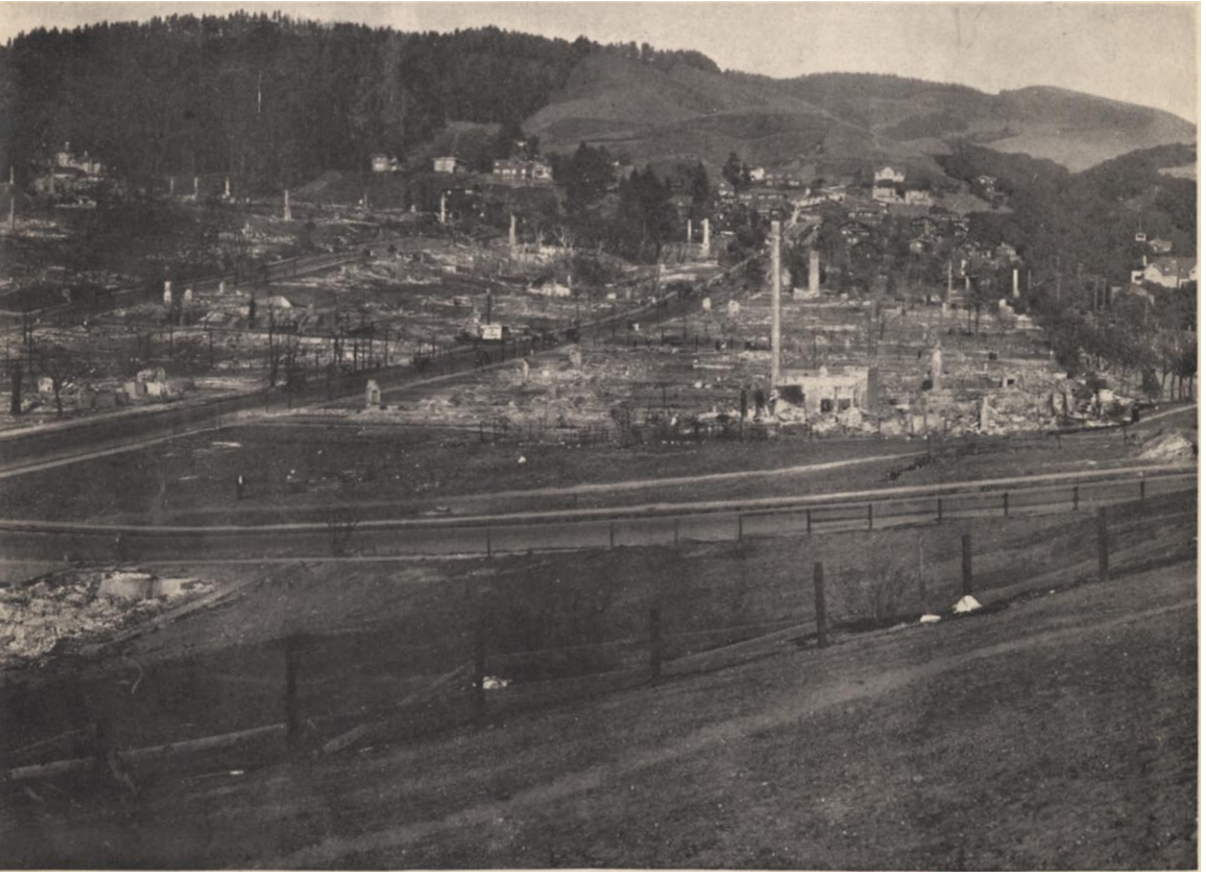
The large amount of shrubbery and shade trees, as shown, contributed largely to the spread of the fire, coupled with the high wind, low humidity and the total inadequacy of the water mains.

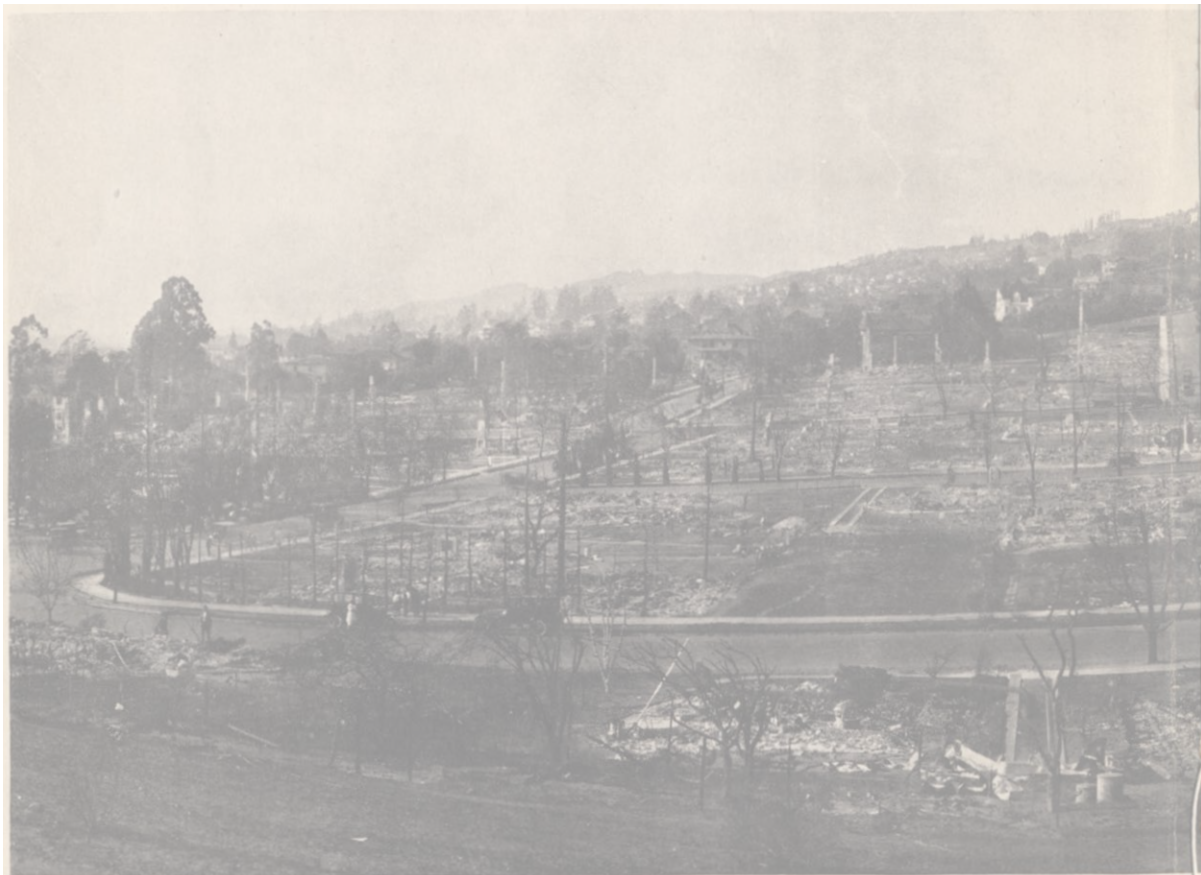
Brush and grass fires swept over hill in background. The arrow at the center, near top, points to location of first house to catch fire. (See illustration and affidavit.)

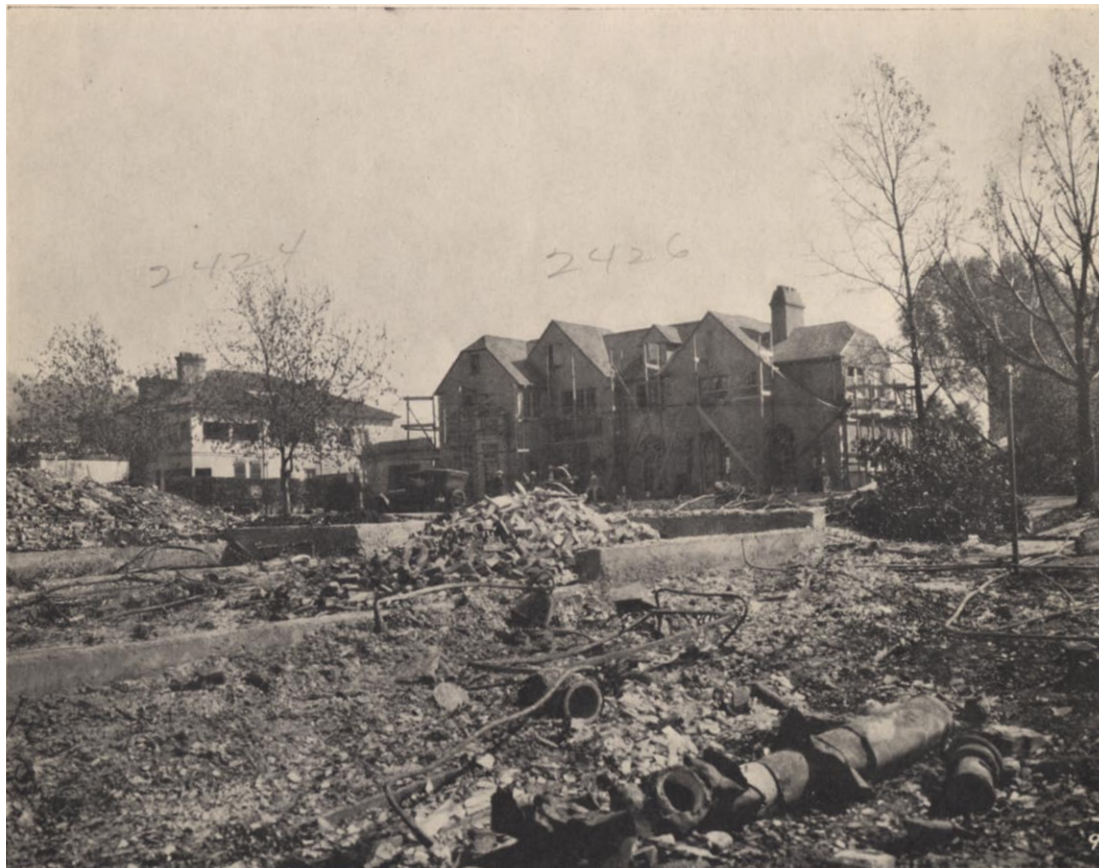
**What a wonderful story
this picture tells!**

These fraternity houses were saved by reason of the efforts of the boys who lived in them. The fire fighting force won out despite lack of water. Everything surrounding was completely destroyed and they were to have been dynamited, but the boys refused to leave the roofs.

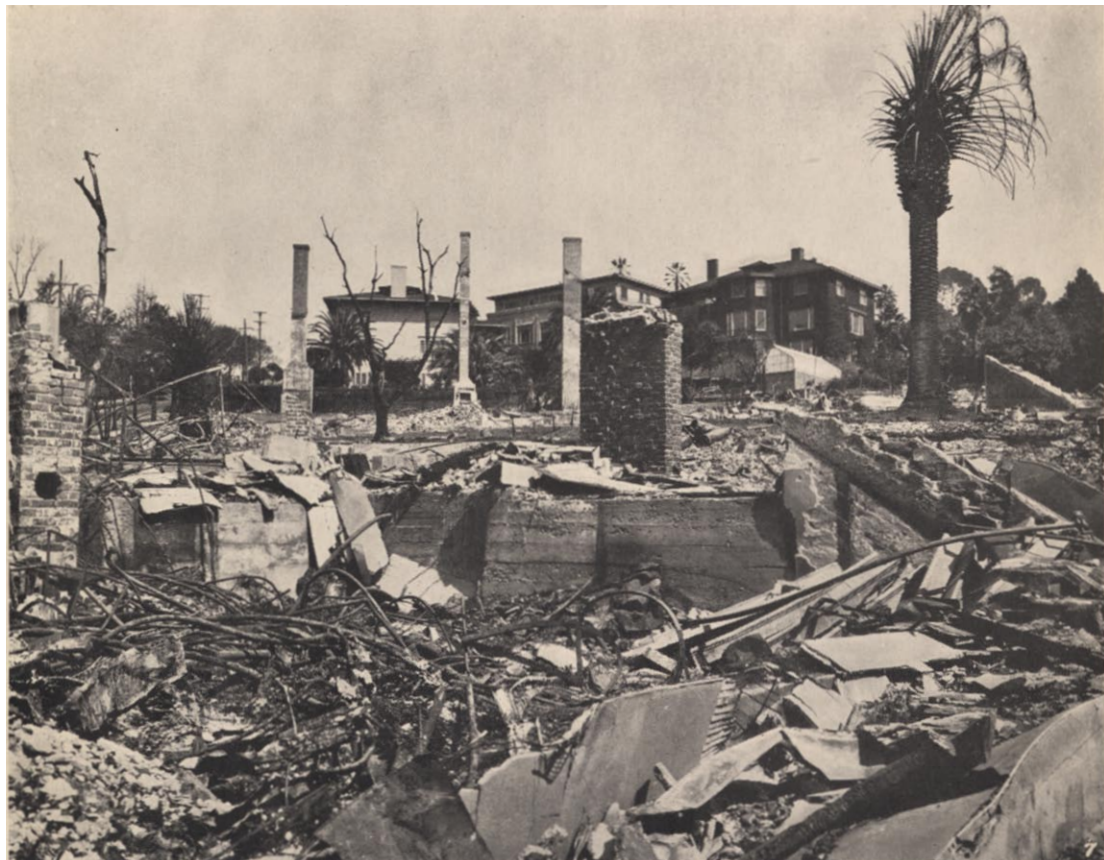
Scene on Heart [*sic*]
Avenue near Scenic Avenue

This photograph shows two stucco houses and one all-shingle house. All these houses had shingle roofs. These houses, which were right in the path of the flames, were saved by a sudden change in the wind. The shingle roofs were not even scorched, despite the rain of sparks that must have fallen on them before the course of the wind changed.

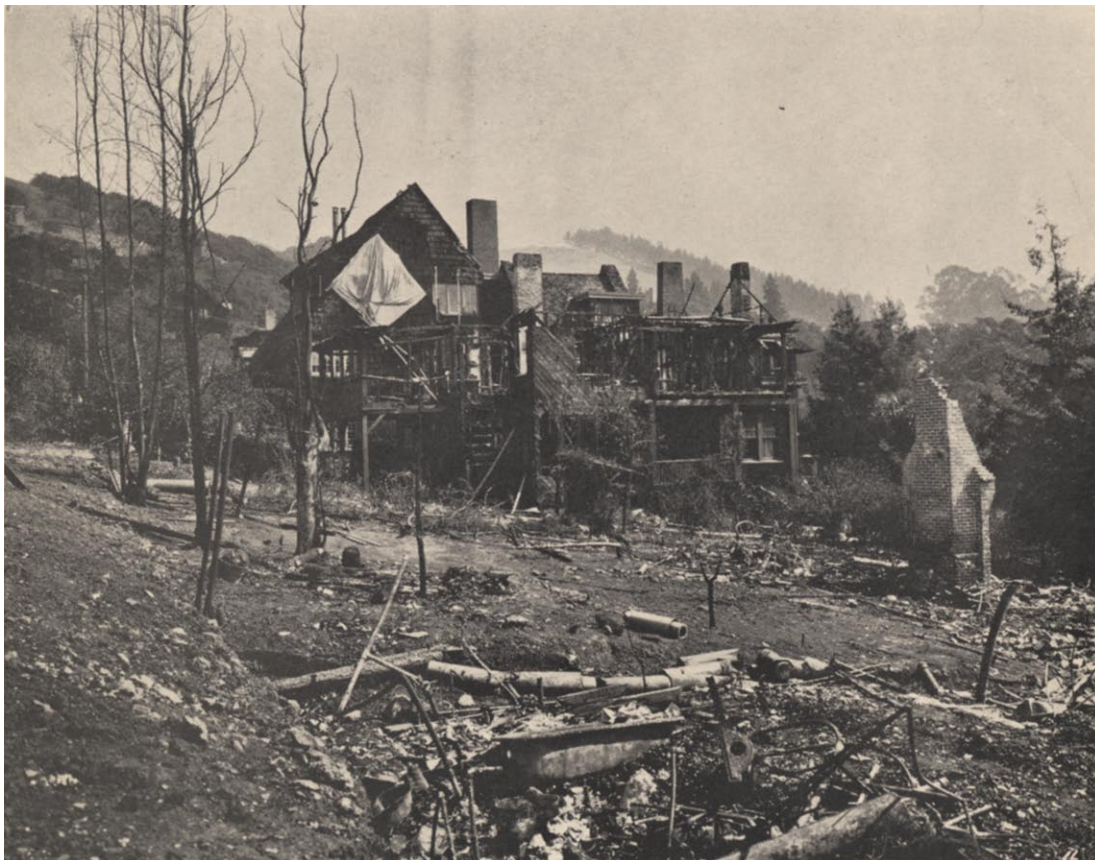
Le Conte and Le Roy Avenues

This house was on the edge of the fire and was separated from the adjoining house by only a fifteen-foot alley. The neighboring house was almost completely destroyed, while this all-shingle structure, though badly scorched, was not destroyed.

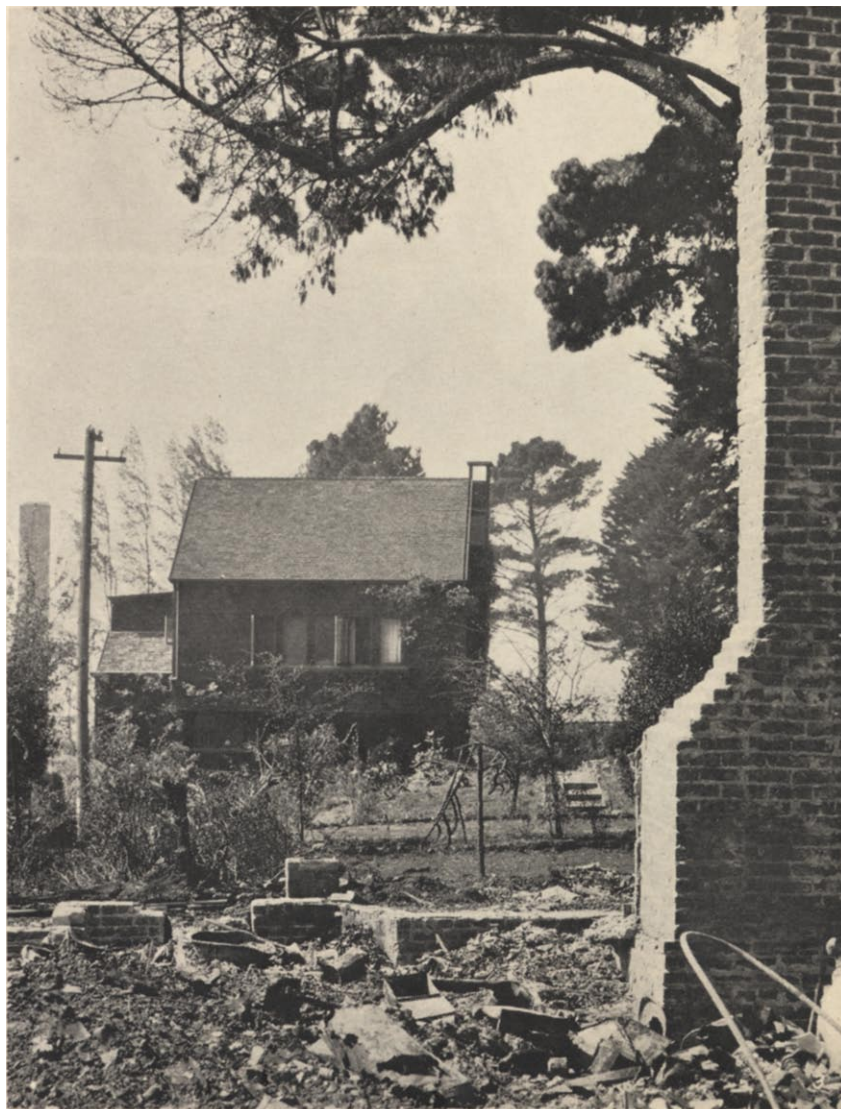
**Greenwood Terrace,
near Buena Vista Way,
looking west.**

An all-shingle house that was completely surrounded by fire, but was saved because it was somewhat isolated. When its location is considered and how it must have been fairly showered by sparks, shingles certainly did not prove such a fire hazard.

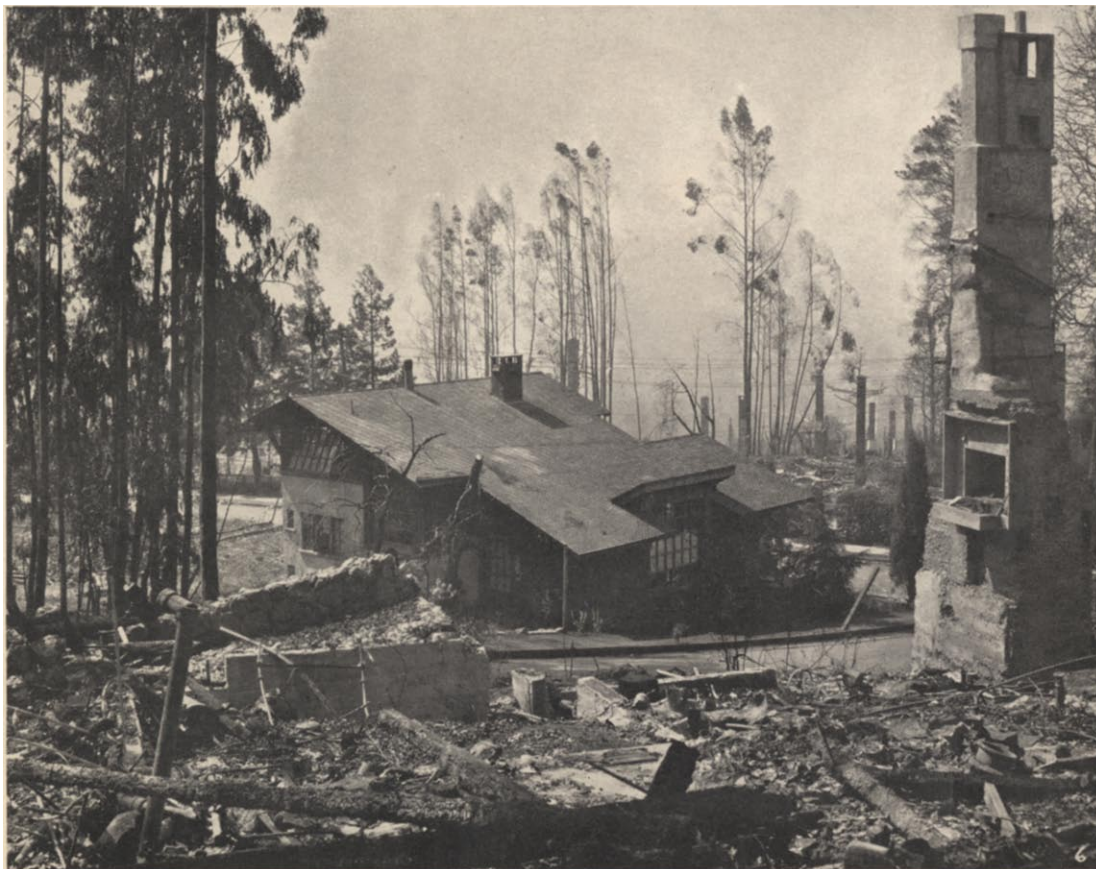
Looking southwest over the ruins of Professor Maybeck' home on Buena Vista Way.

Another example of a shingle roof house completely surrounded by fire. Note particularly the fir tree shown at the corner of roof. This tree caught fire and was chopped down while burning. Shingles were charred by burning branches and needles, but the house was saved. All surrounding shrubbery was killed by the heat of the fire.

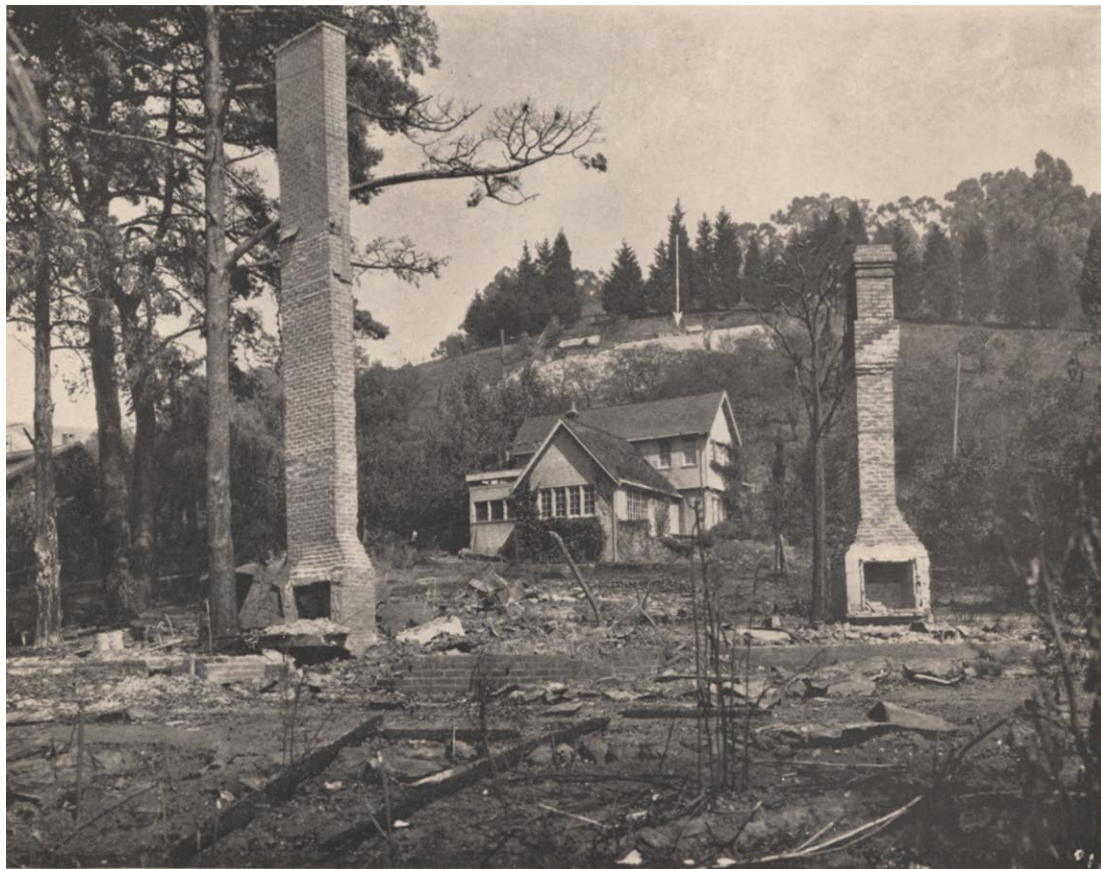
**Greenwood Terrace,
near Buena Vista Way,
looking east.**

The arrow indicates a stucco and concrete house that was completely destroyed. The wind blew directly across the shingle roof home that was saved, but it remains as good as it ever was. Fire ran through the shrubbery, the garden was ruined, and the ivy on the side of the house was killed by the heat. Despite this fiery ordeal, it escaped intact.

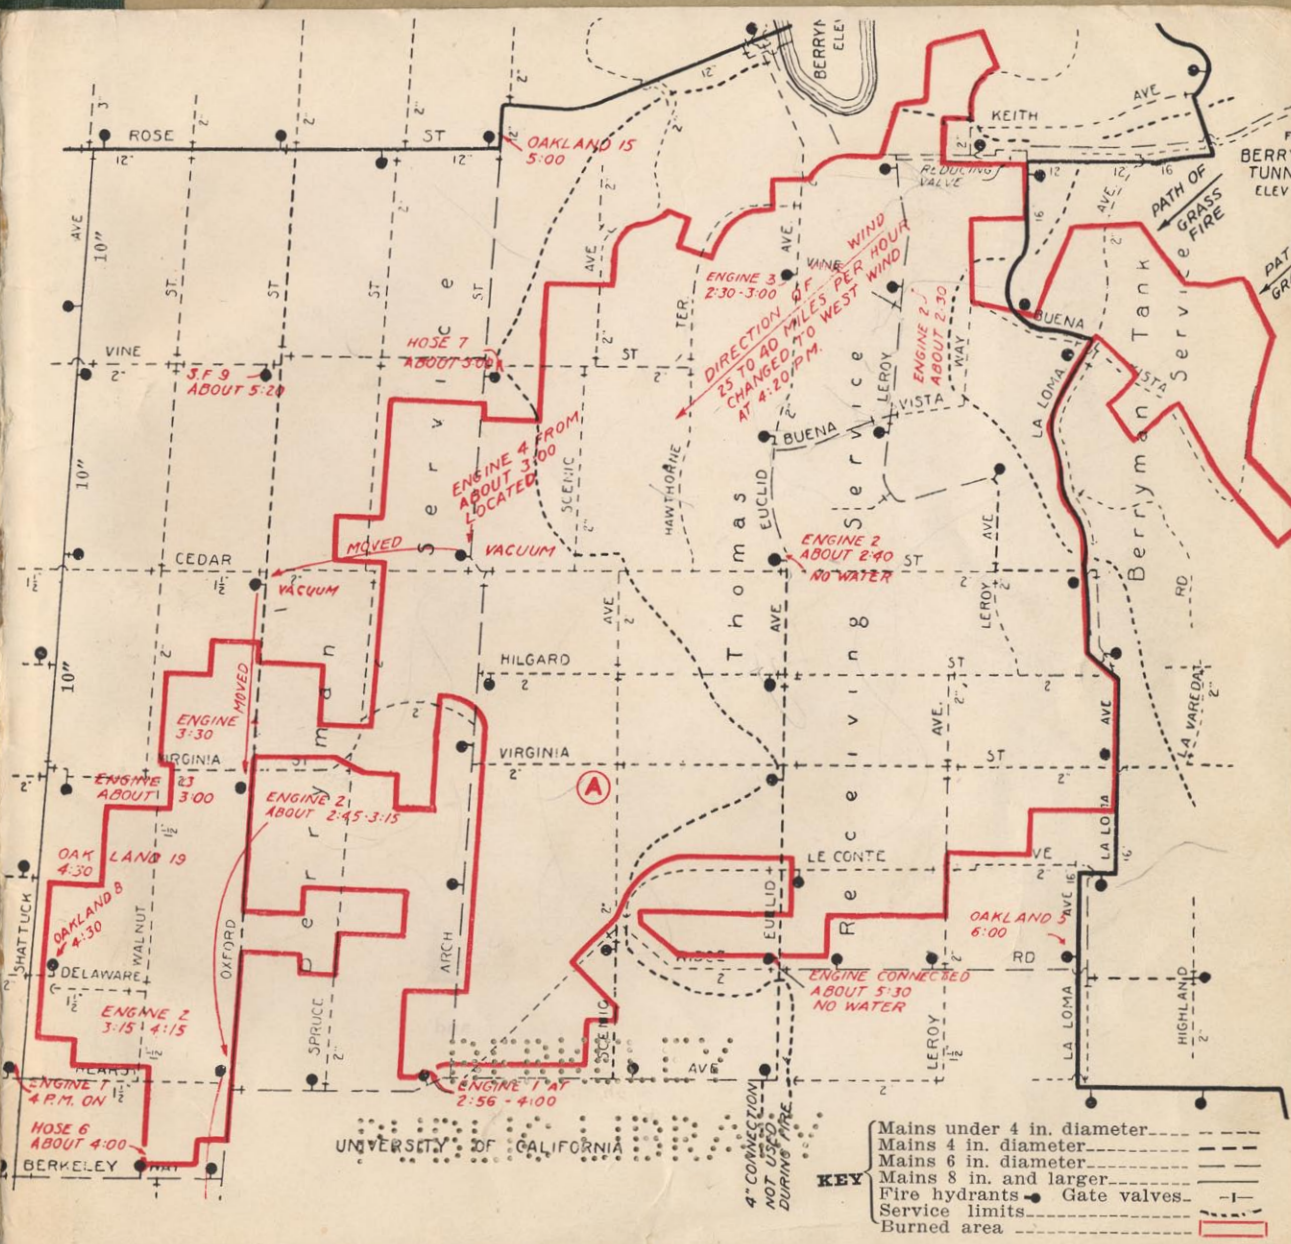
The attention of the reader is called to the map on the last page of this booklet. A brief study of this will show conclusively that the heavy loss in this fire is chargeable to the inadequacy of the size of the water mains and the lack of water in these mains. Note the following facts:

- (1) Within the burned area nearly all mains were only 2 inches in diameter.
- (2) That of the two **used** mains over 4 inches in diameter, located in the burned area, one had no water and one is marked "Vacuum."
- (3) That with one exception the whole eastern side of the fire was stopped along the exact line of a large and presumably adequate 16-inch main.

- (4) That the fire stopped on the south and west at or about the time the wind changed and also at or near 10-inch mains.

4" CONNECTION NOT USED DURING FIRE

ENGINE 2 ABOUT 2:40 NO WATER

ENGINE CONNECTED ABOUT 5:30 NO WATER
