The story
of the
Berkeley Fire

The Story of the
BERKELEY FIRE
Of September 17, 1923

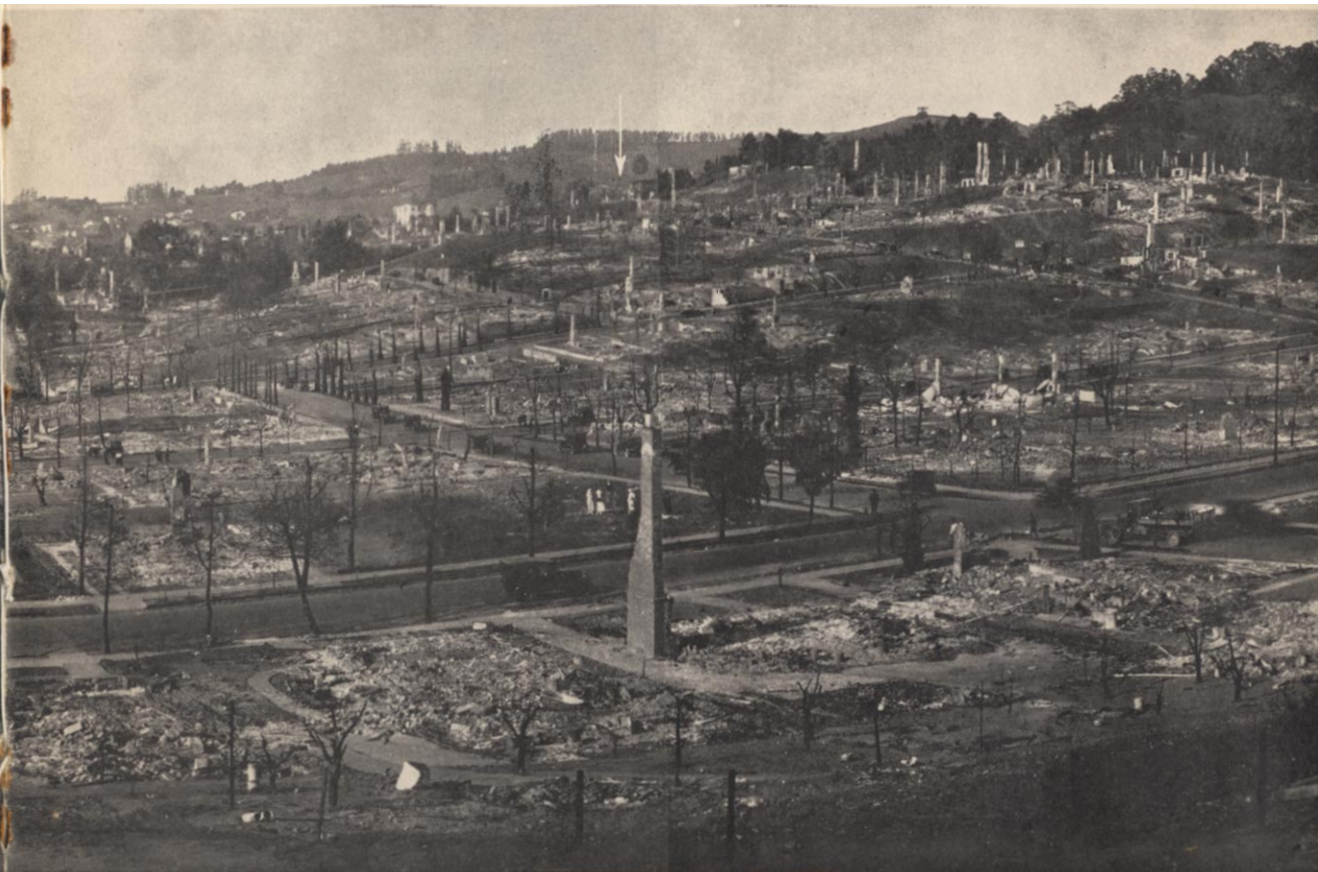
PANORAMIC VIEW OF THE BERKELEY FIRE

Brush and grass fires swept over hill in background. The arrow at the center, near top, points to location of first house to catch fire. (See illustration and affidavit.)

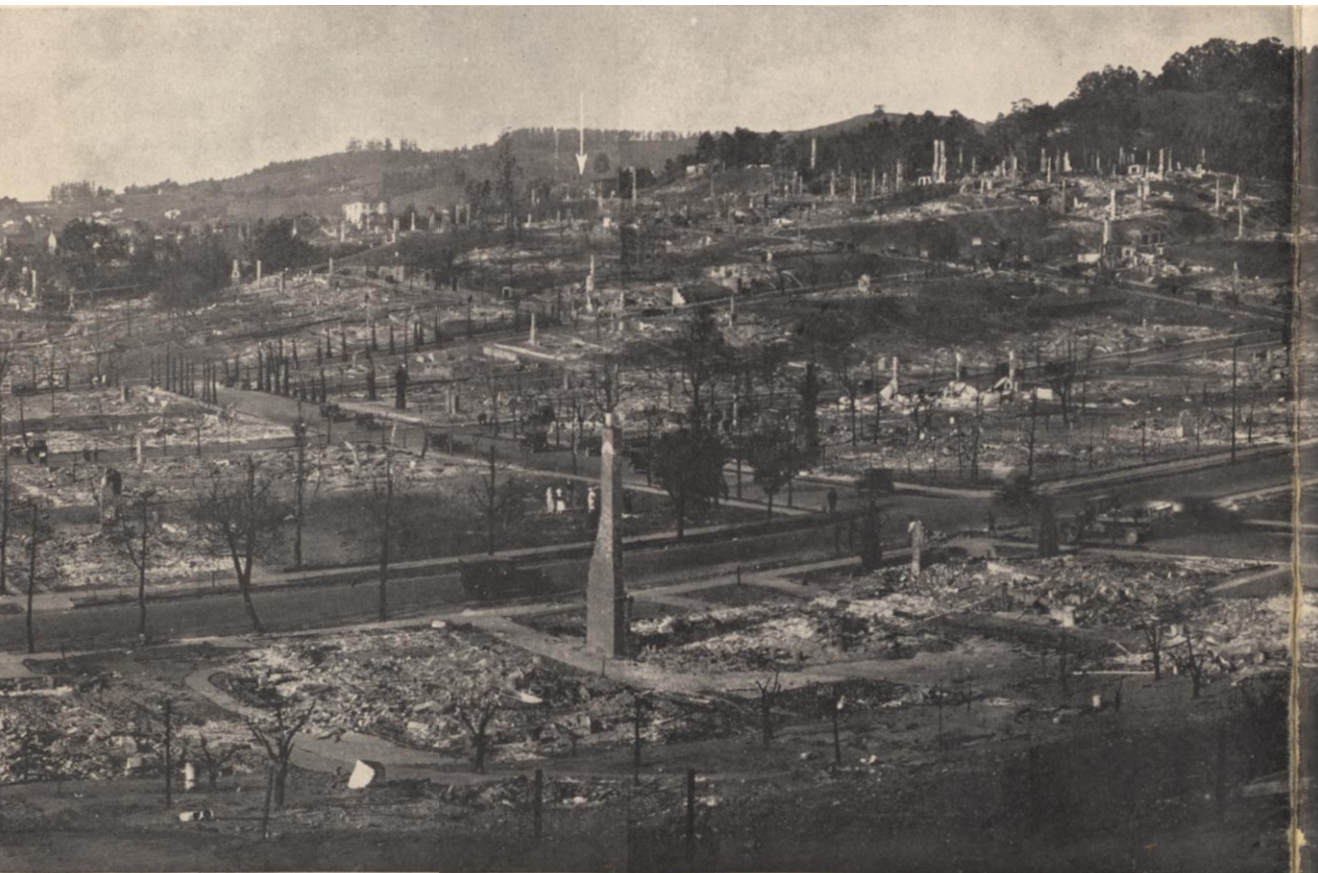
PANORAMIC VIEW OF THE BERKELEY FIRE

The large amount of shrubbery and shade trees, as shown, contributed largely to the spread of the fire, coupled with the high wind, low humidity and the total inadequacy of the water mains.
